DEBRIS/ICE/TPS ASSESSMENT  
AND  
PHOTOGRAPHIC ANALYSIS  
OF  
SHUTTLE MISSION STS-32R

January 9, 1990

Gregory N. Katnik  
NASA/Kennedy Space Center  
TV-MSD-22

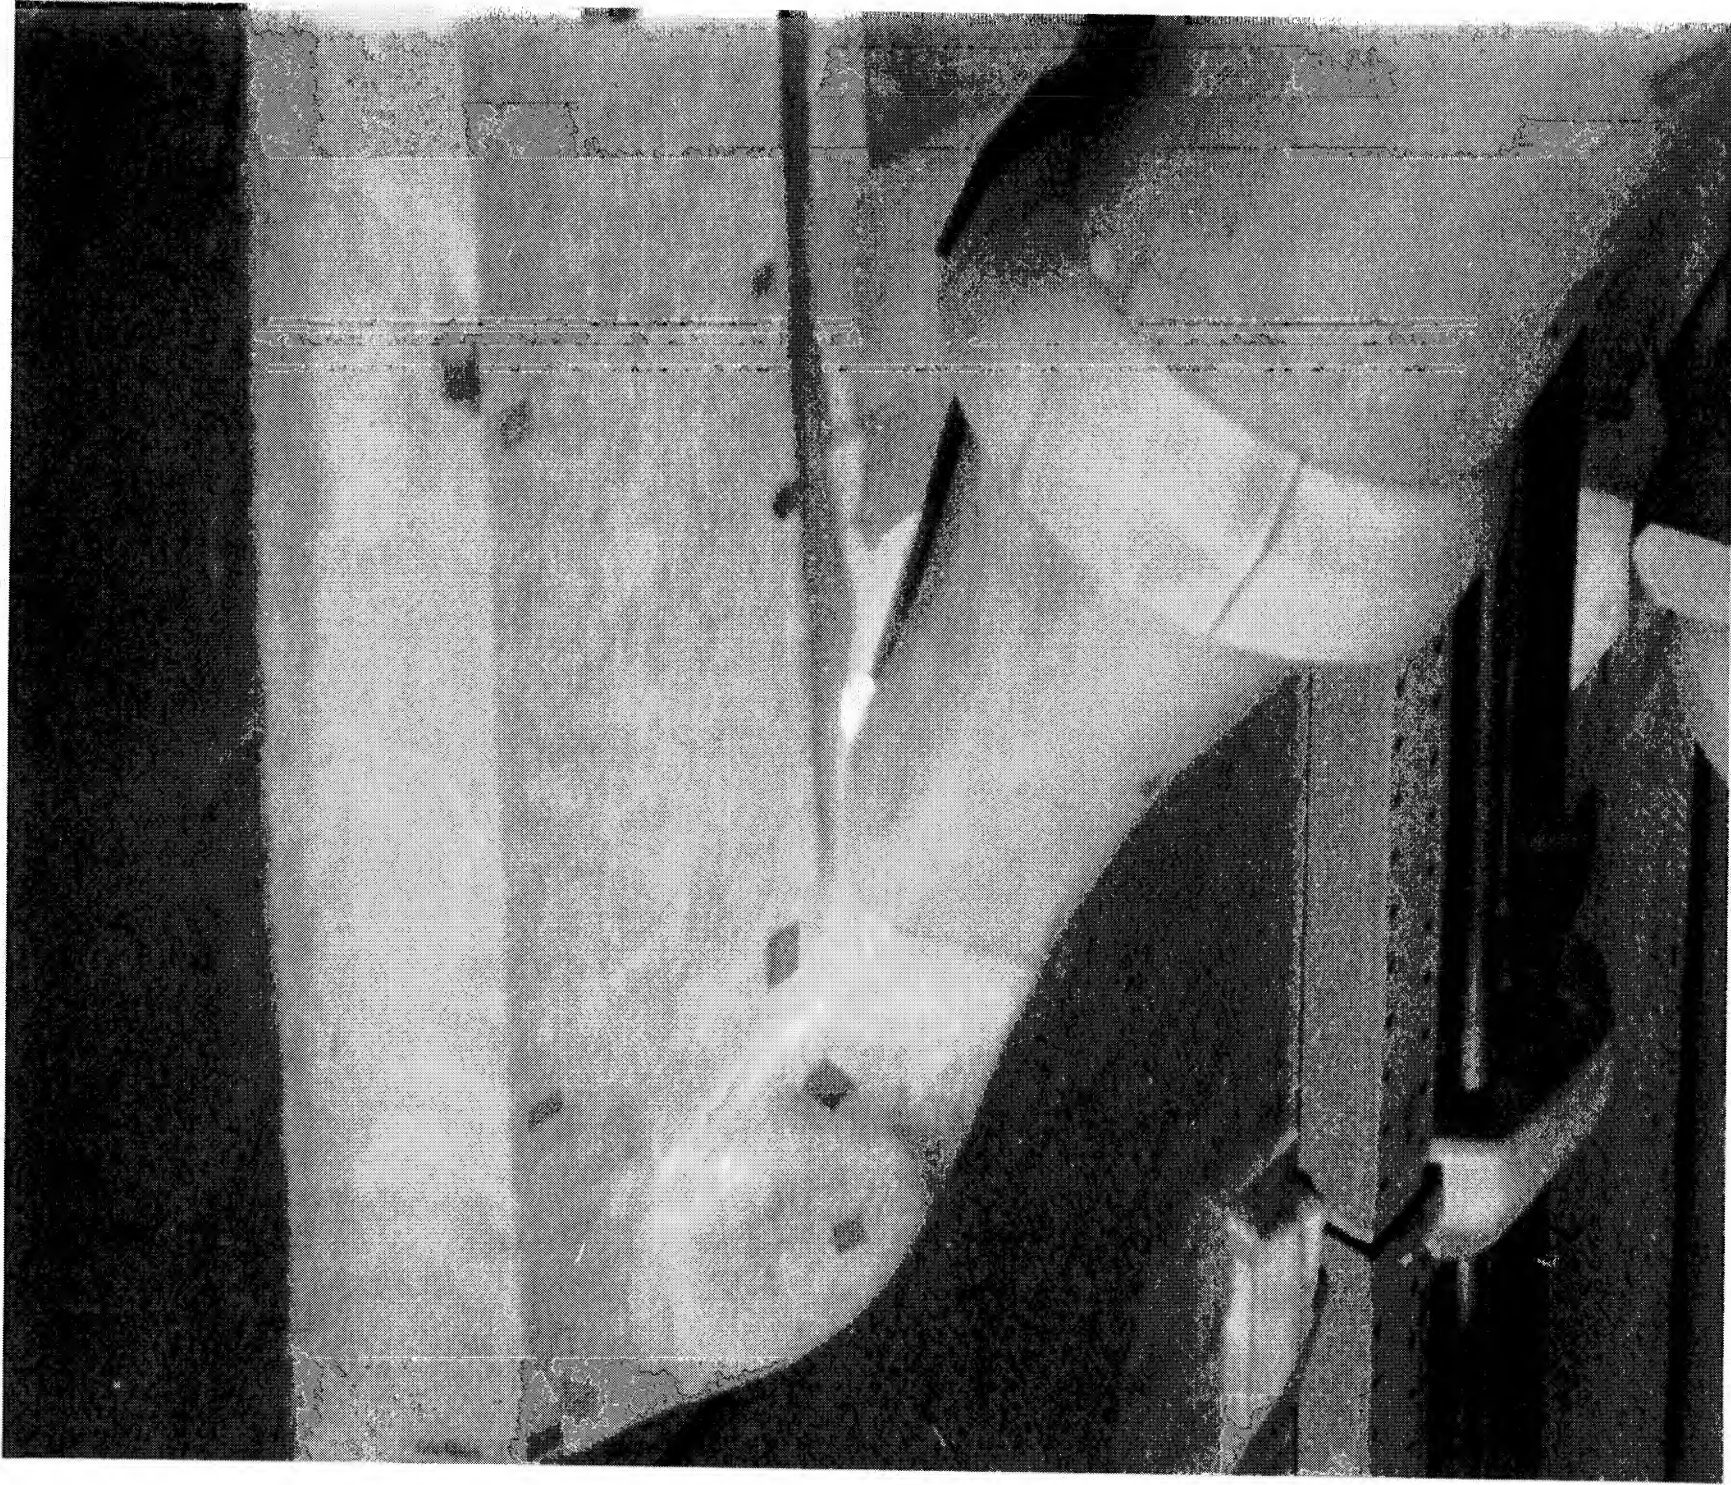
A small TPS crack caused a frost spot to form in the thrust  
strut-to-longeron interface

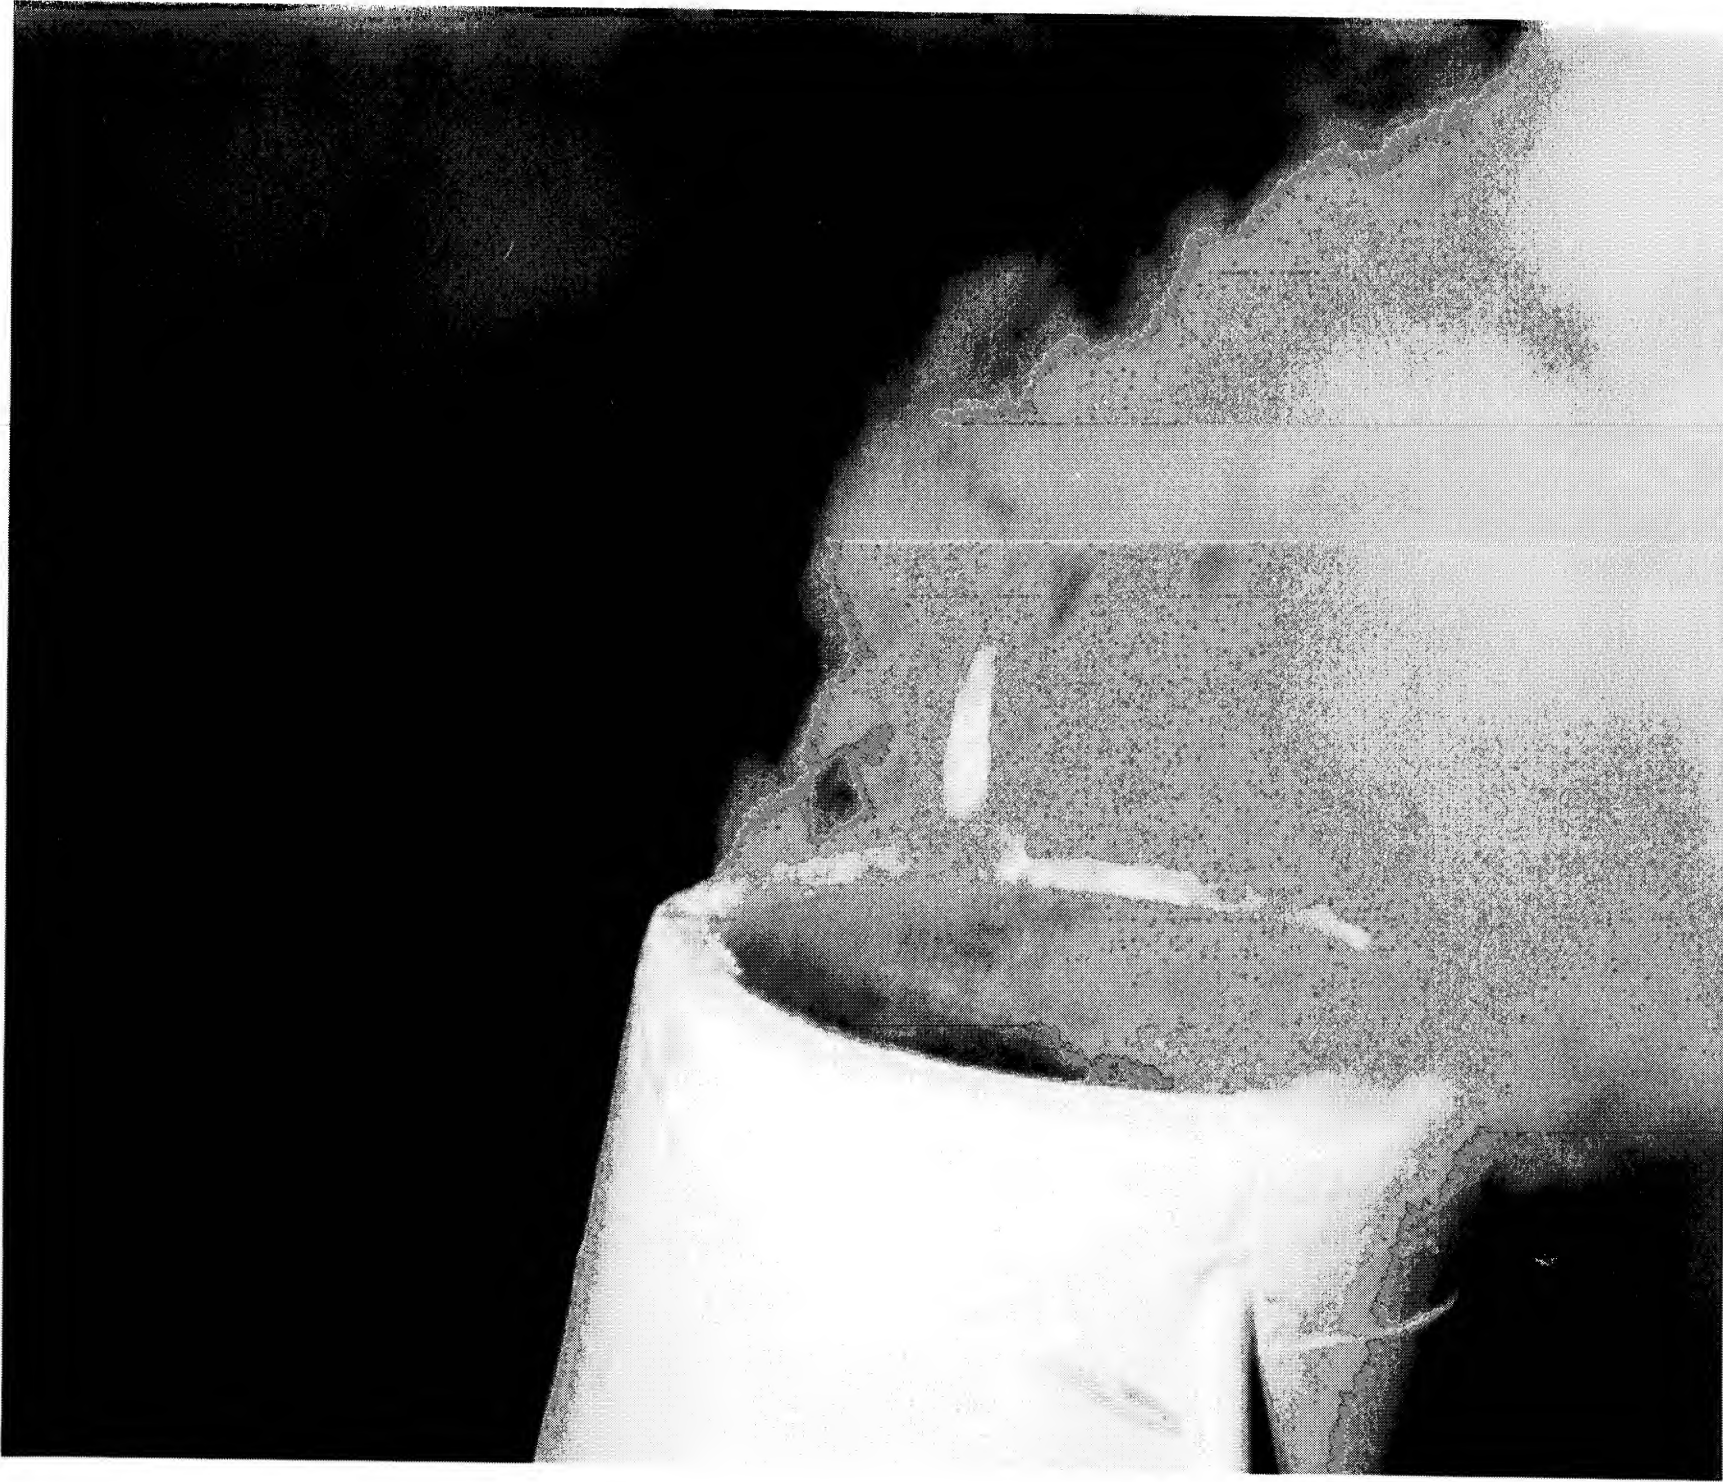
Omitting the hydro diverter on the north GOX vent duct caused  
dripping water/condensate to form 8-inch icicles

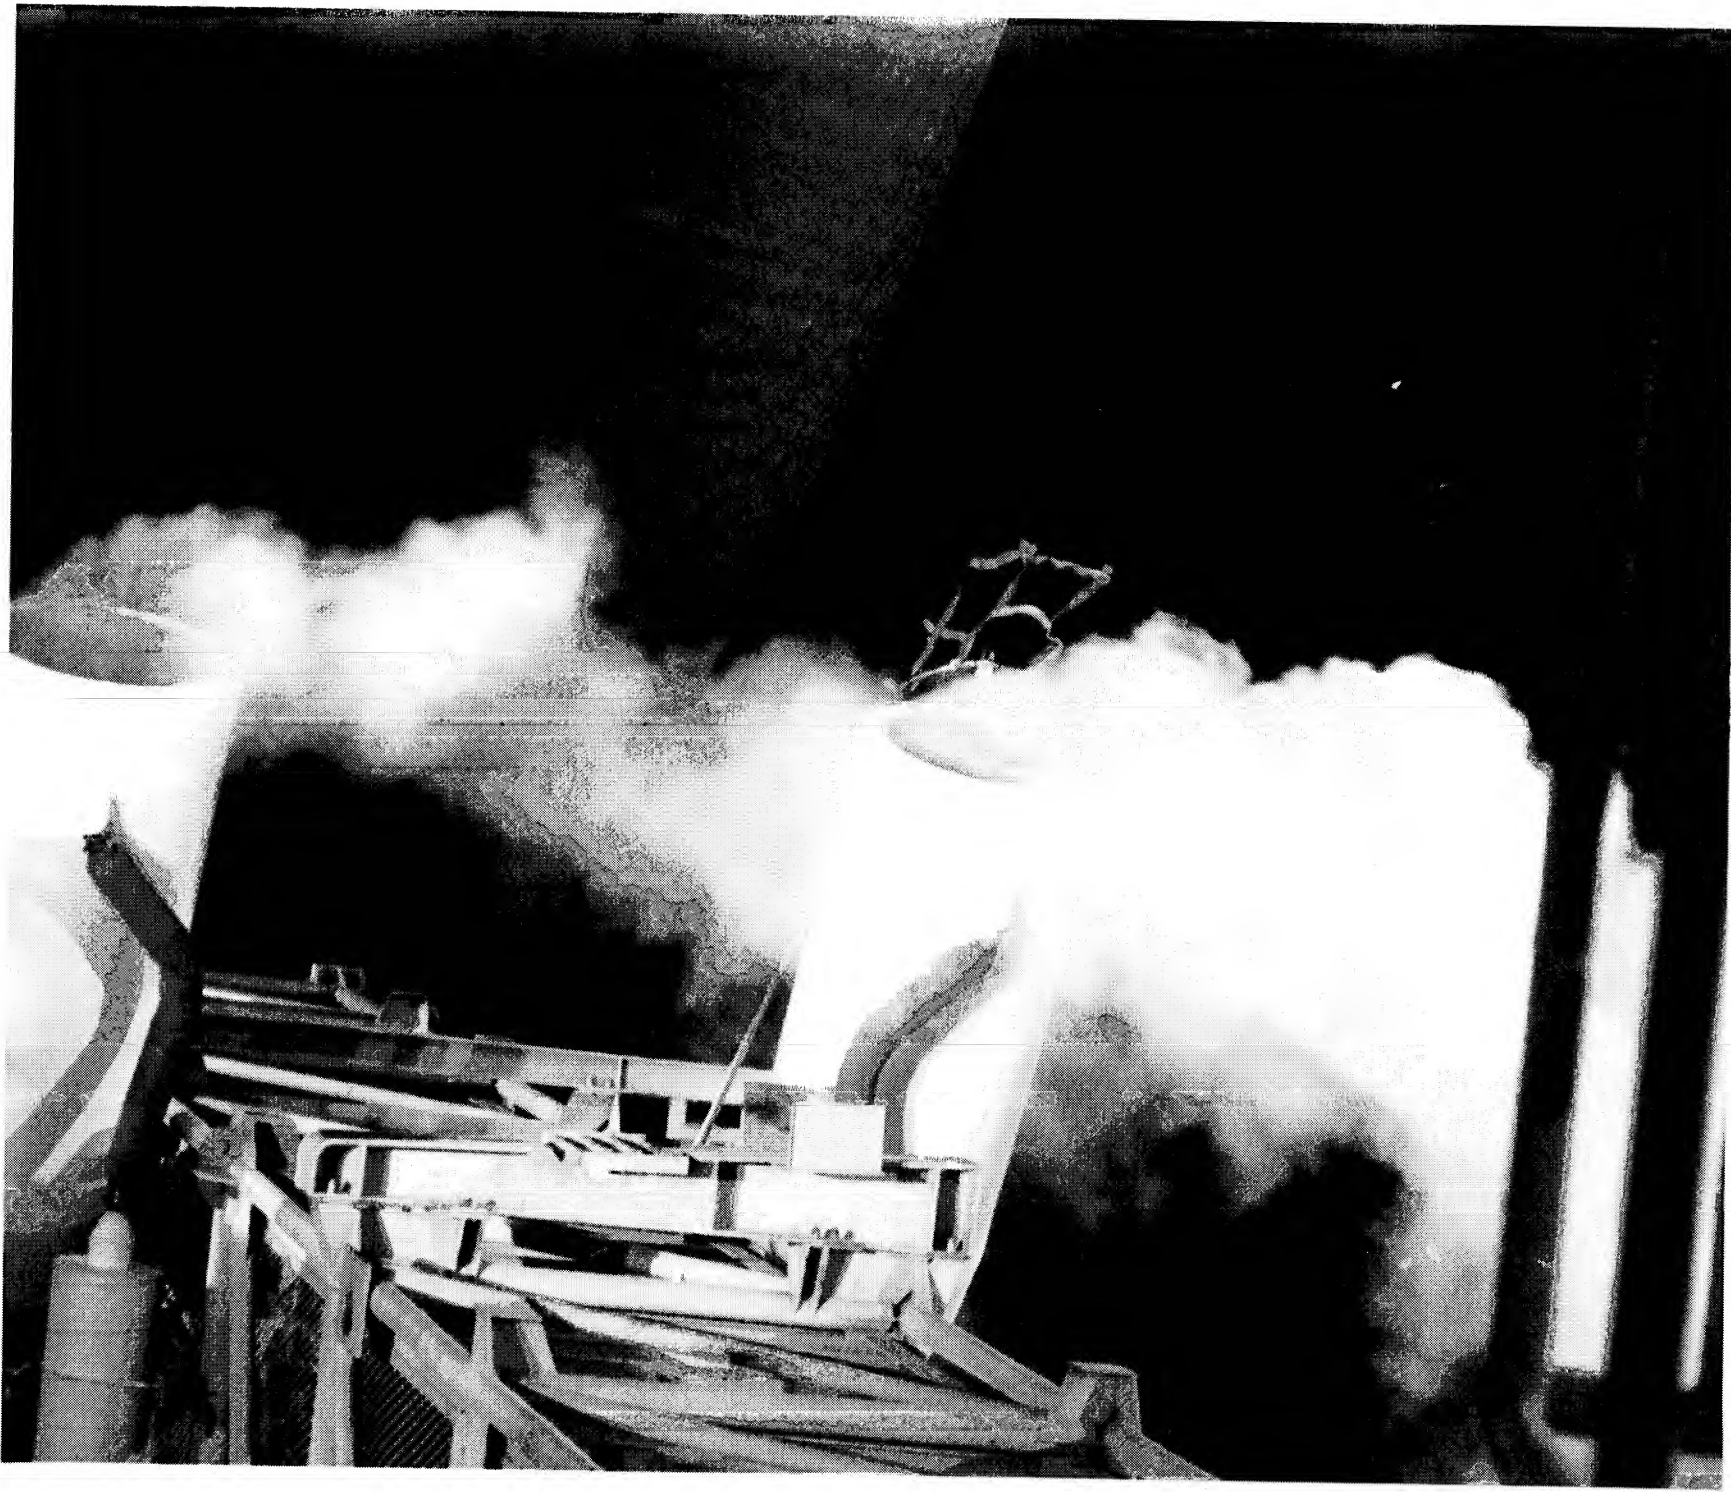
Successful removal of the icicles by the Ice Team prevented  
TPS damage on the vehicle from falling icicles.

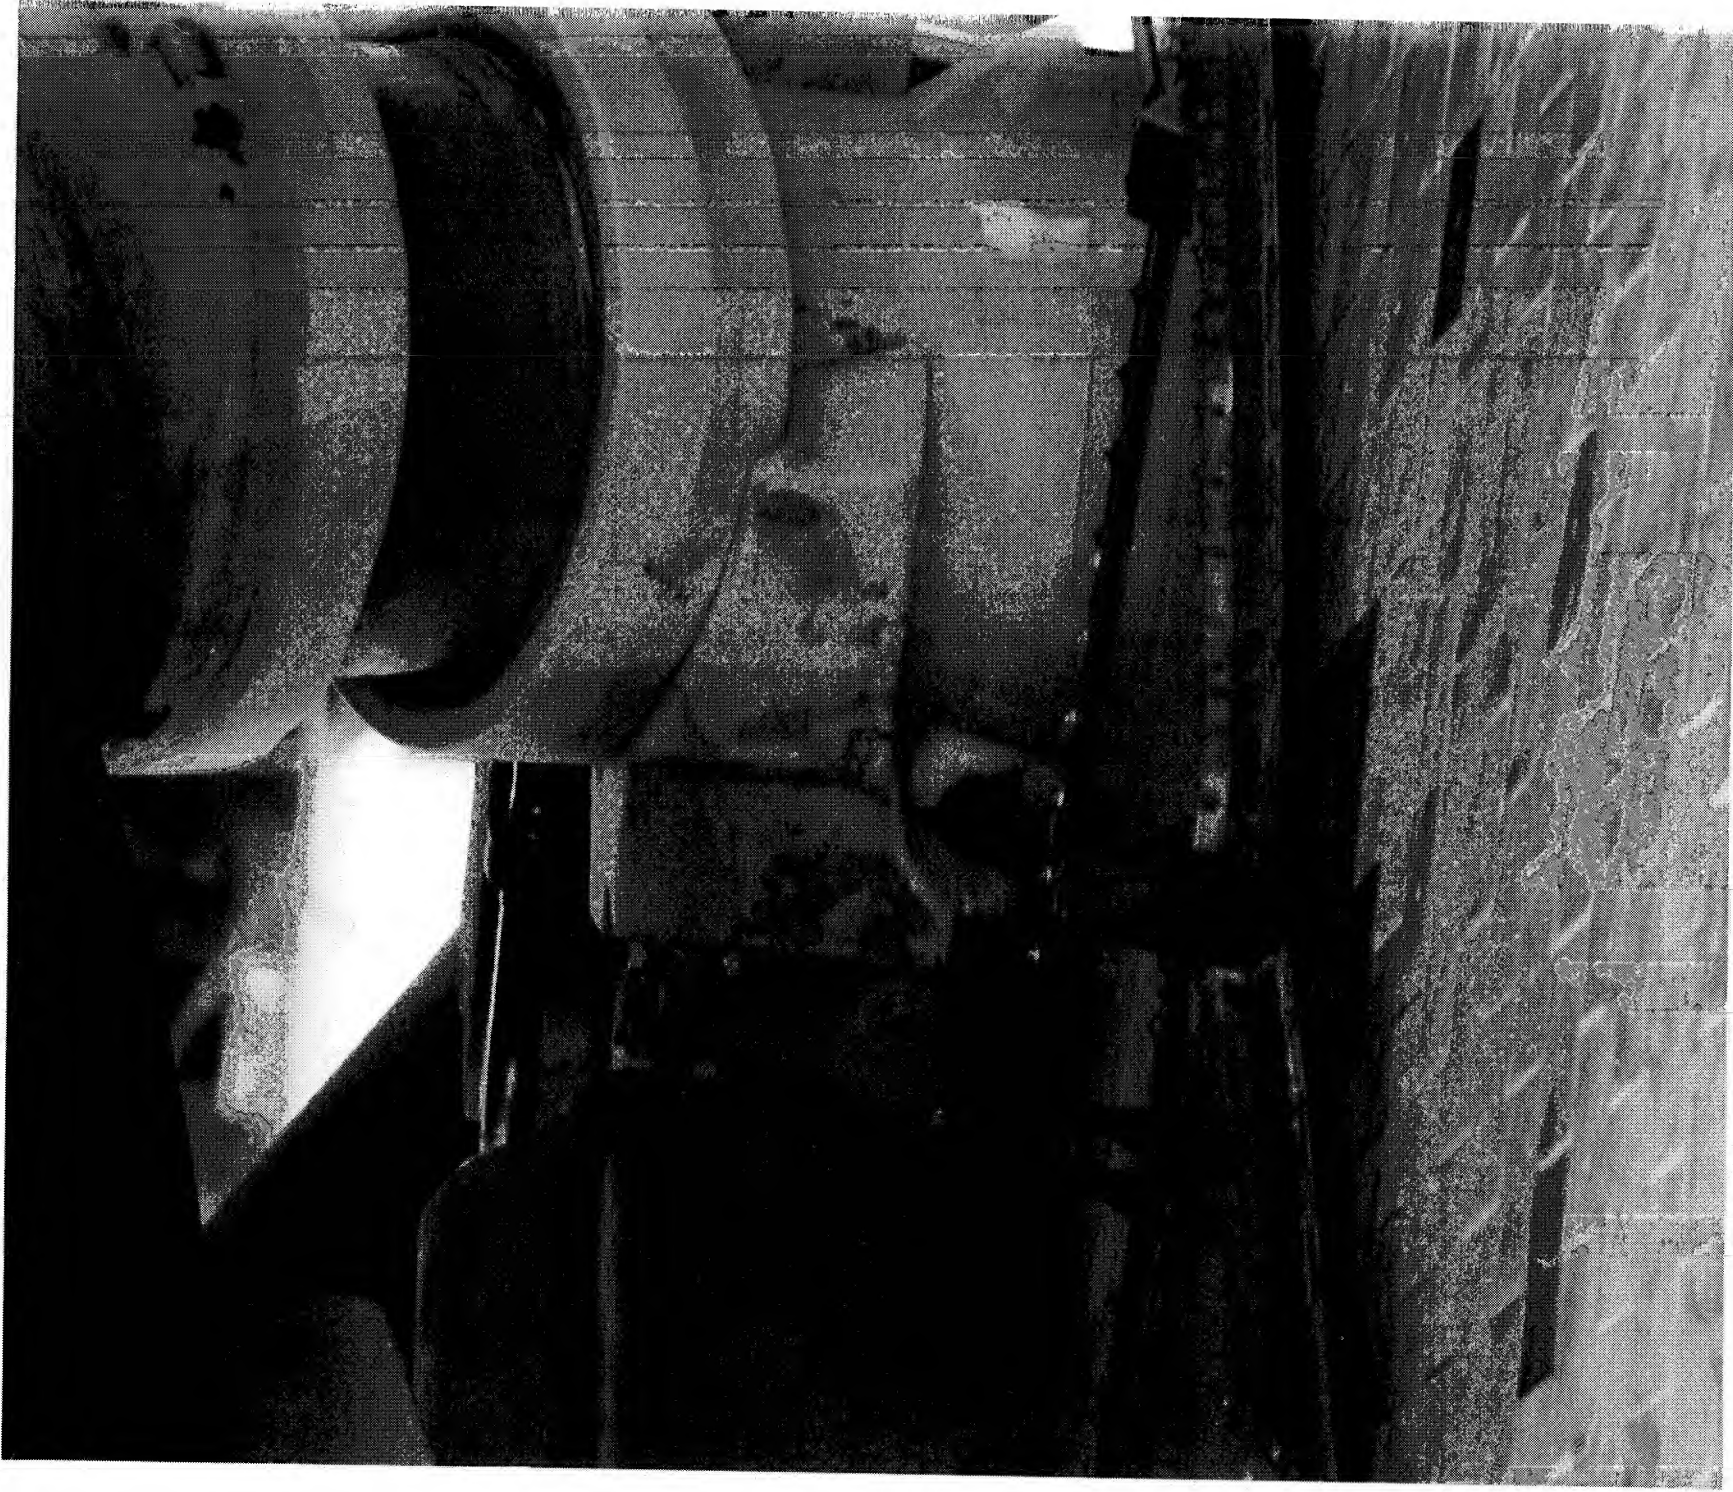
Although no ice/frost was present in the LH2 feedline bellows  
after drain, hard ice was still attached to the purge vents.

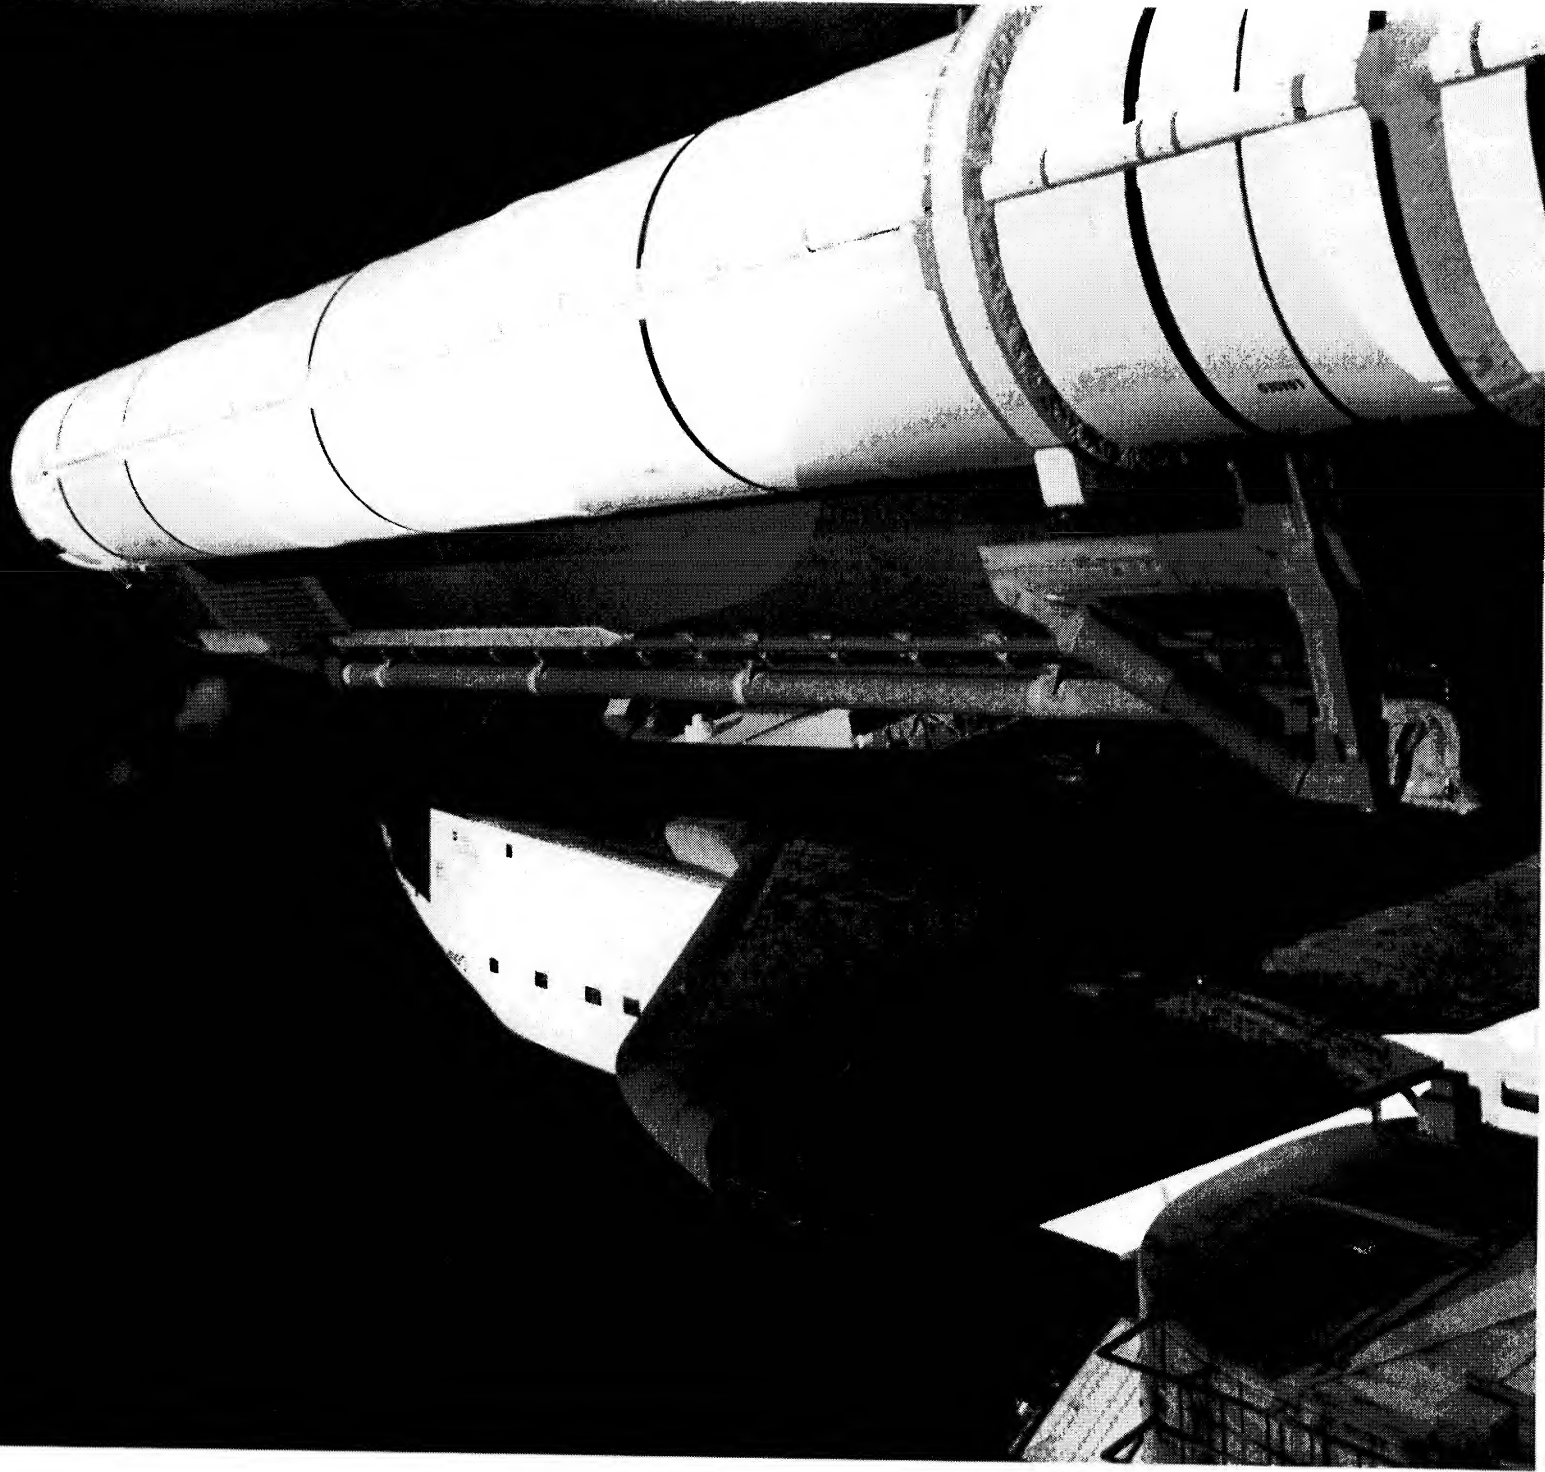
No ice/frost had formed on the acreage in the +Y+Z quadrant  
though a frost line formed along the PAL ramp

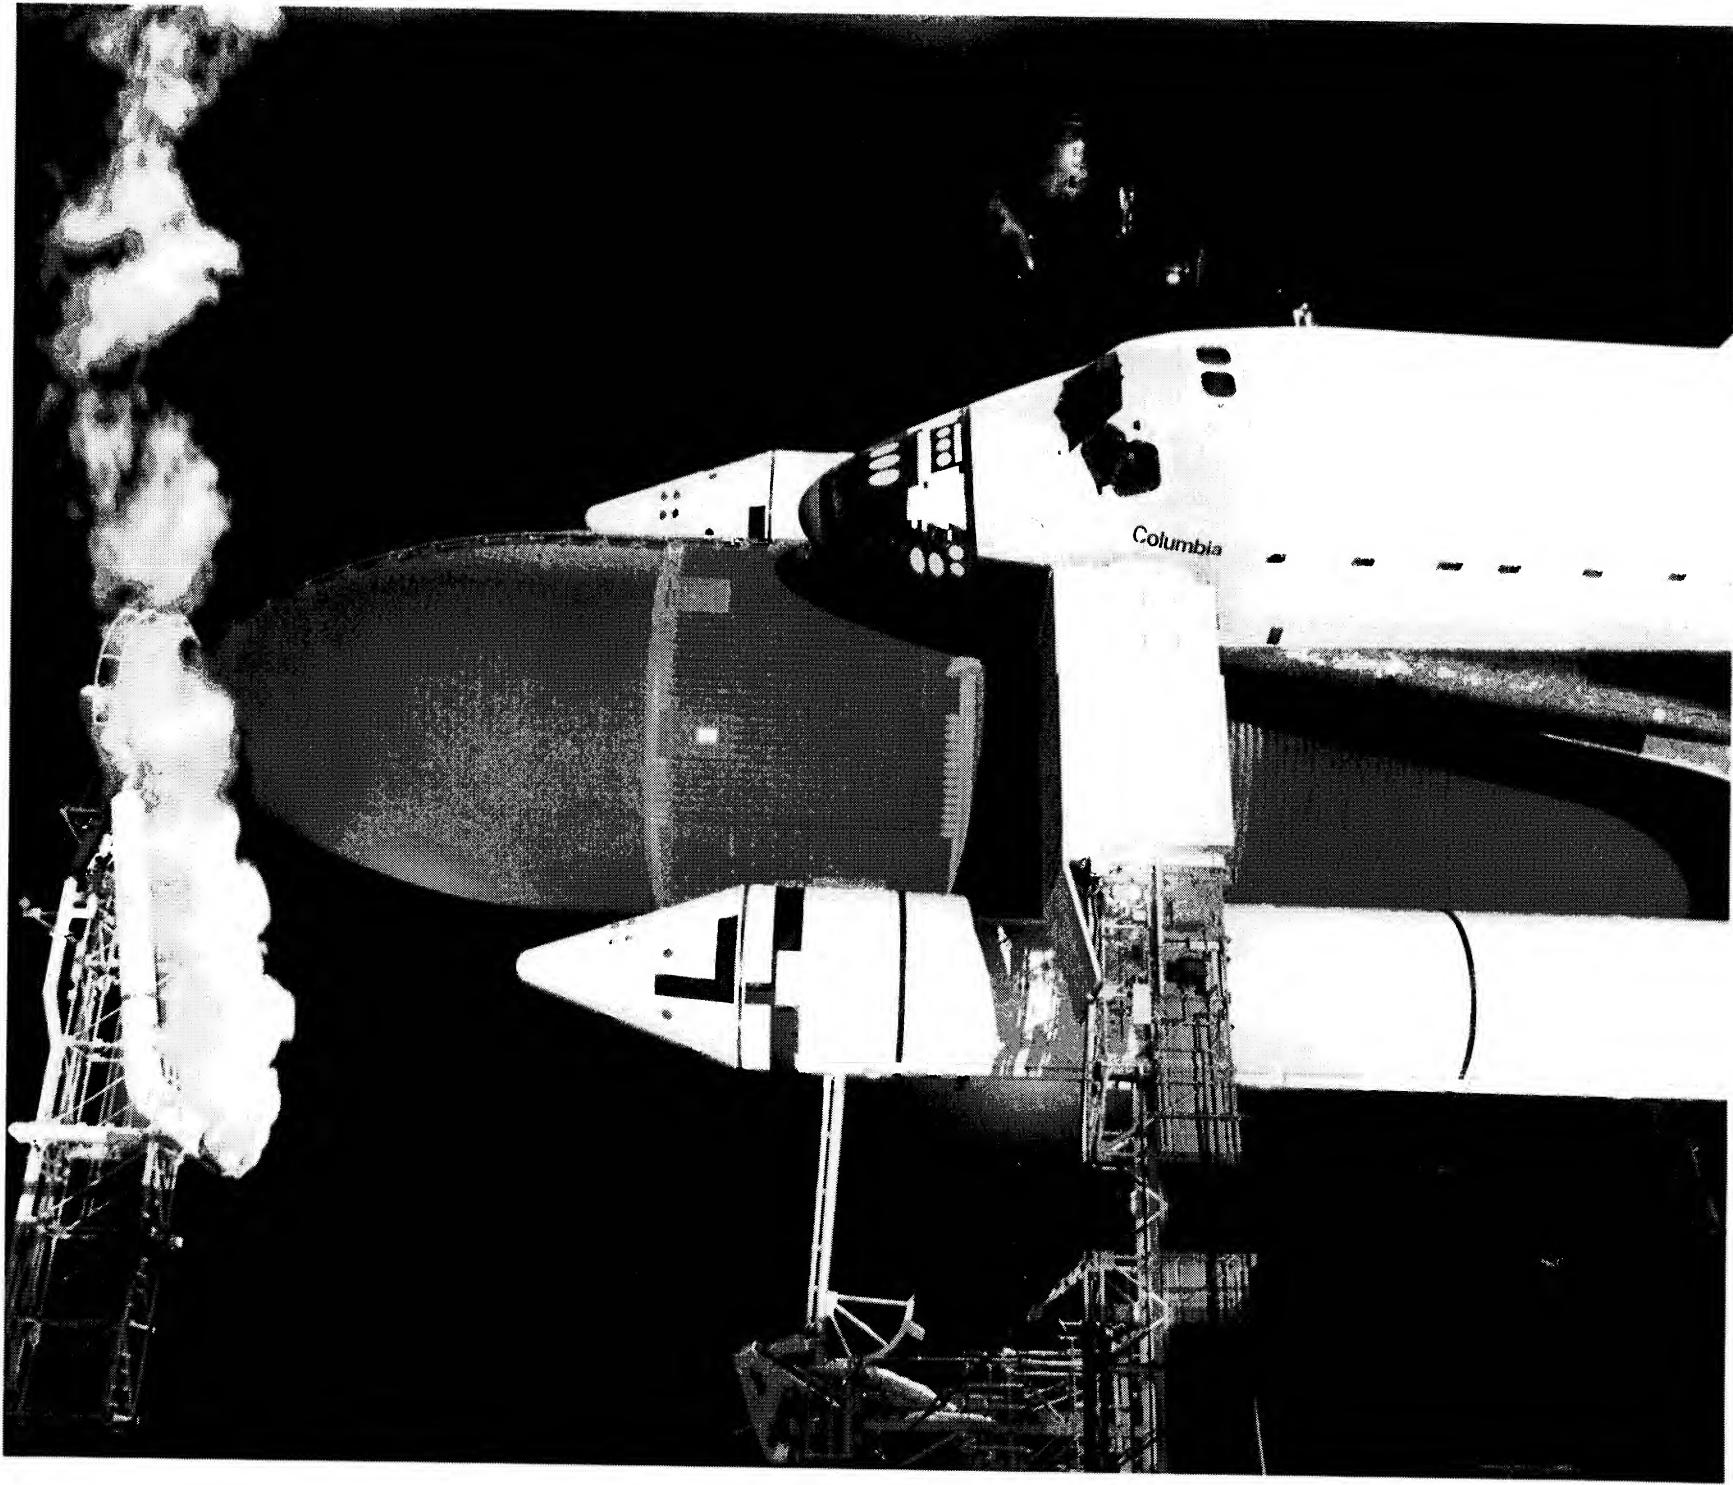
Although westerly winds blew GOX vapors past the LO2 tank  
ogive, no ice/frost had accumulated in the no-ice region

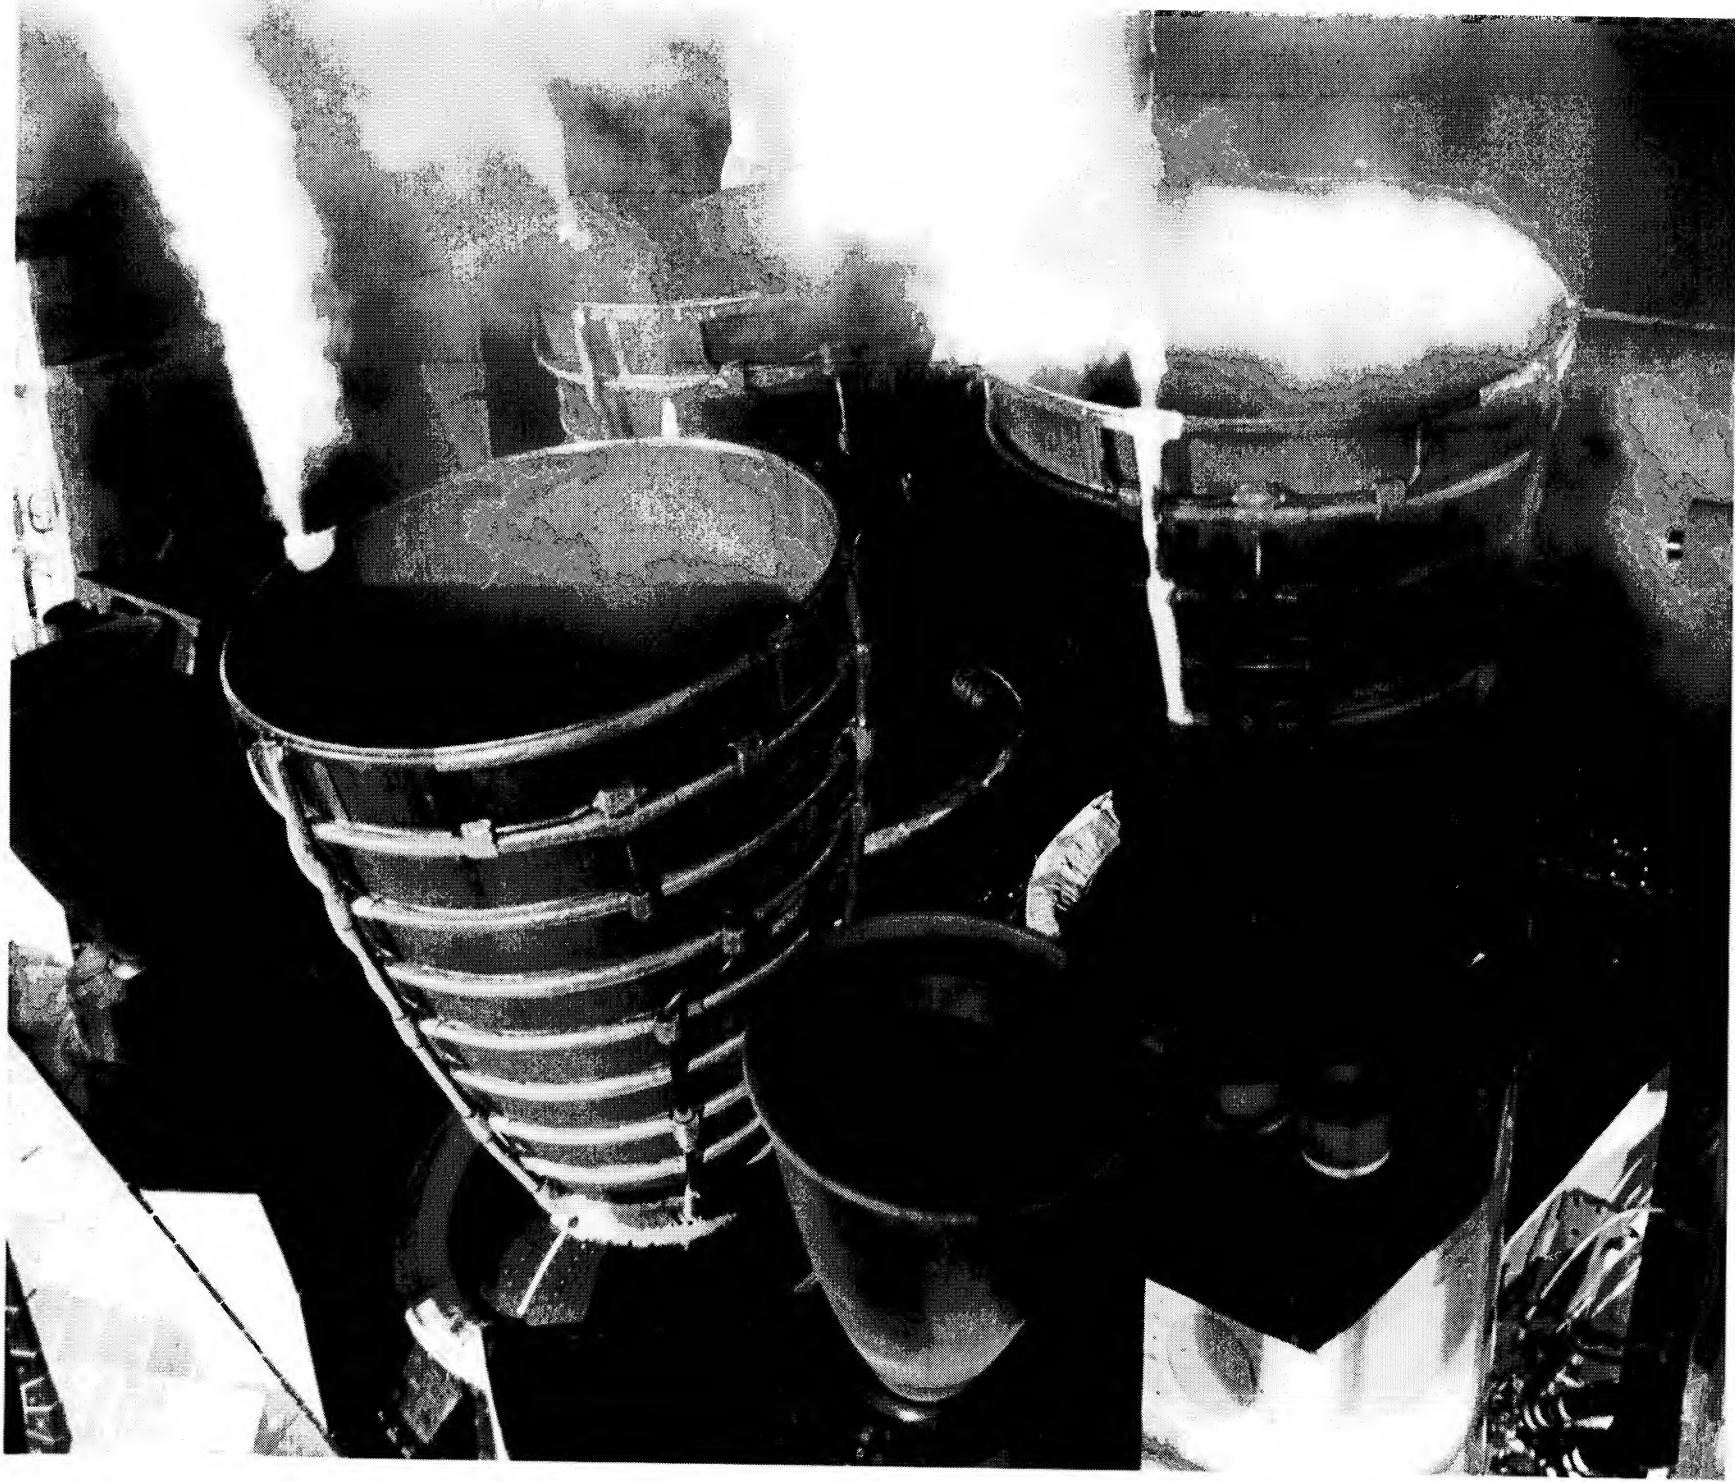
Overall view of the SSME's. Note ice/frost on the engine mounted heat shield interfaces and SSME #2 LO2 drain line

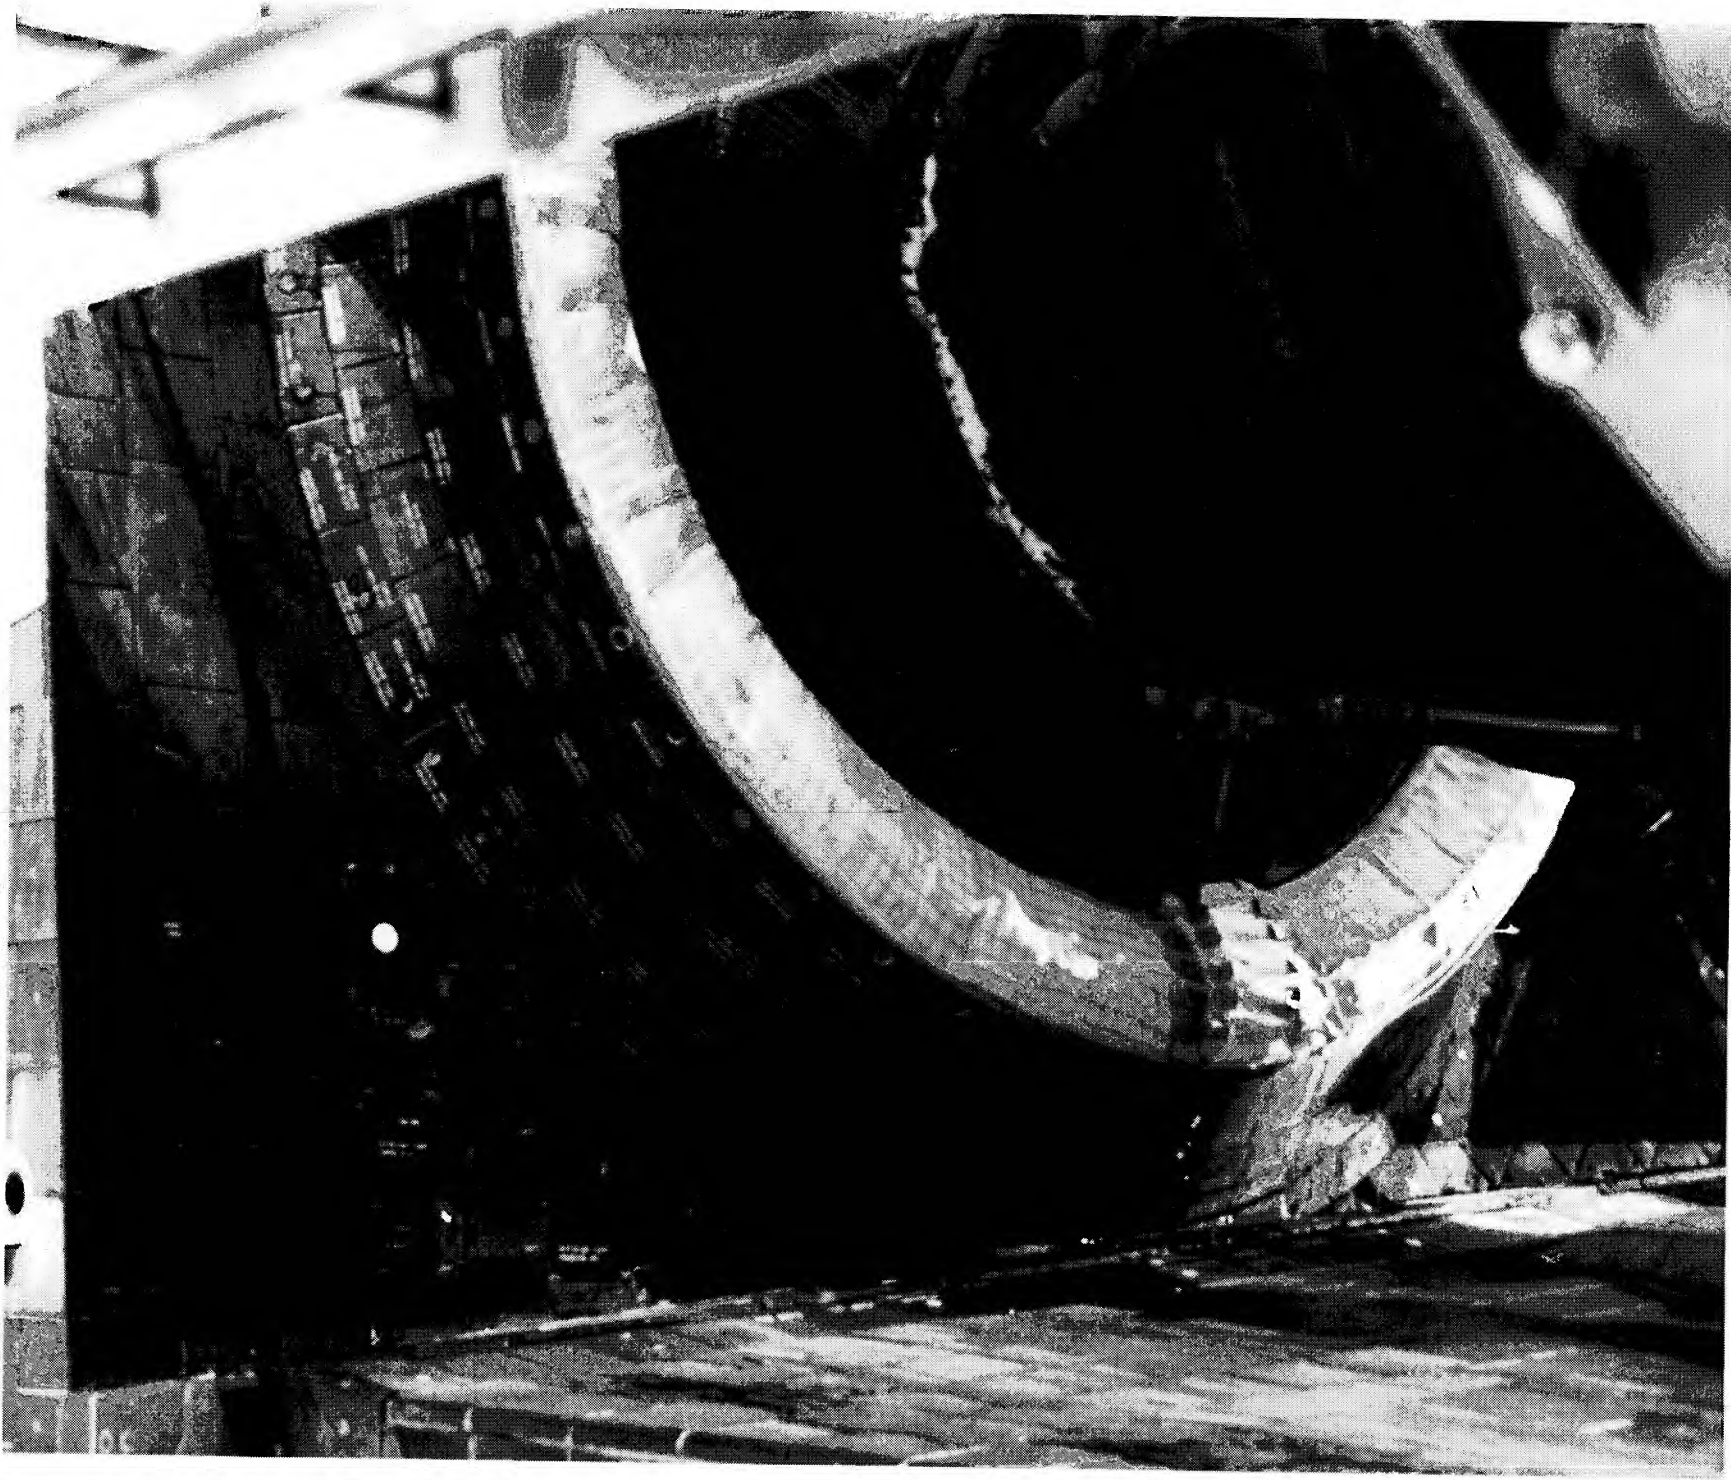
SSME #2 exhibits condensate on the engine heat shield and frost along the interface.. Note frost spot on base heat shield vent.

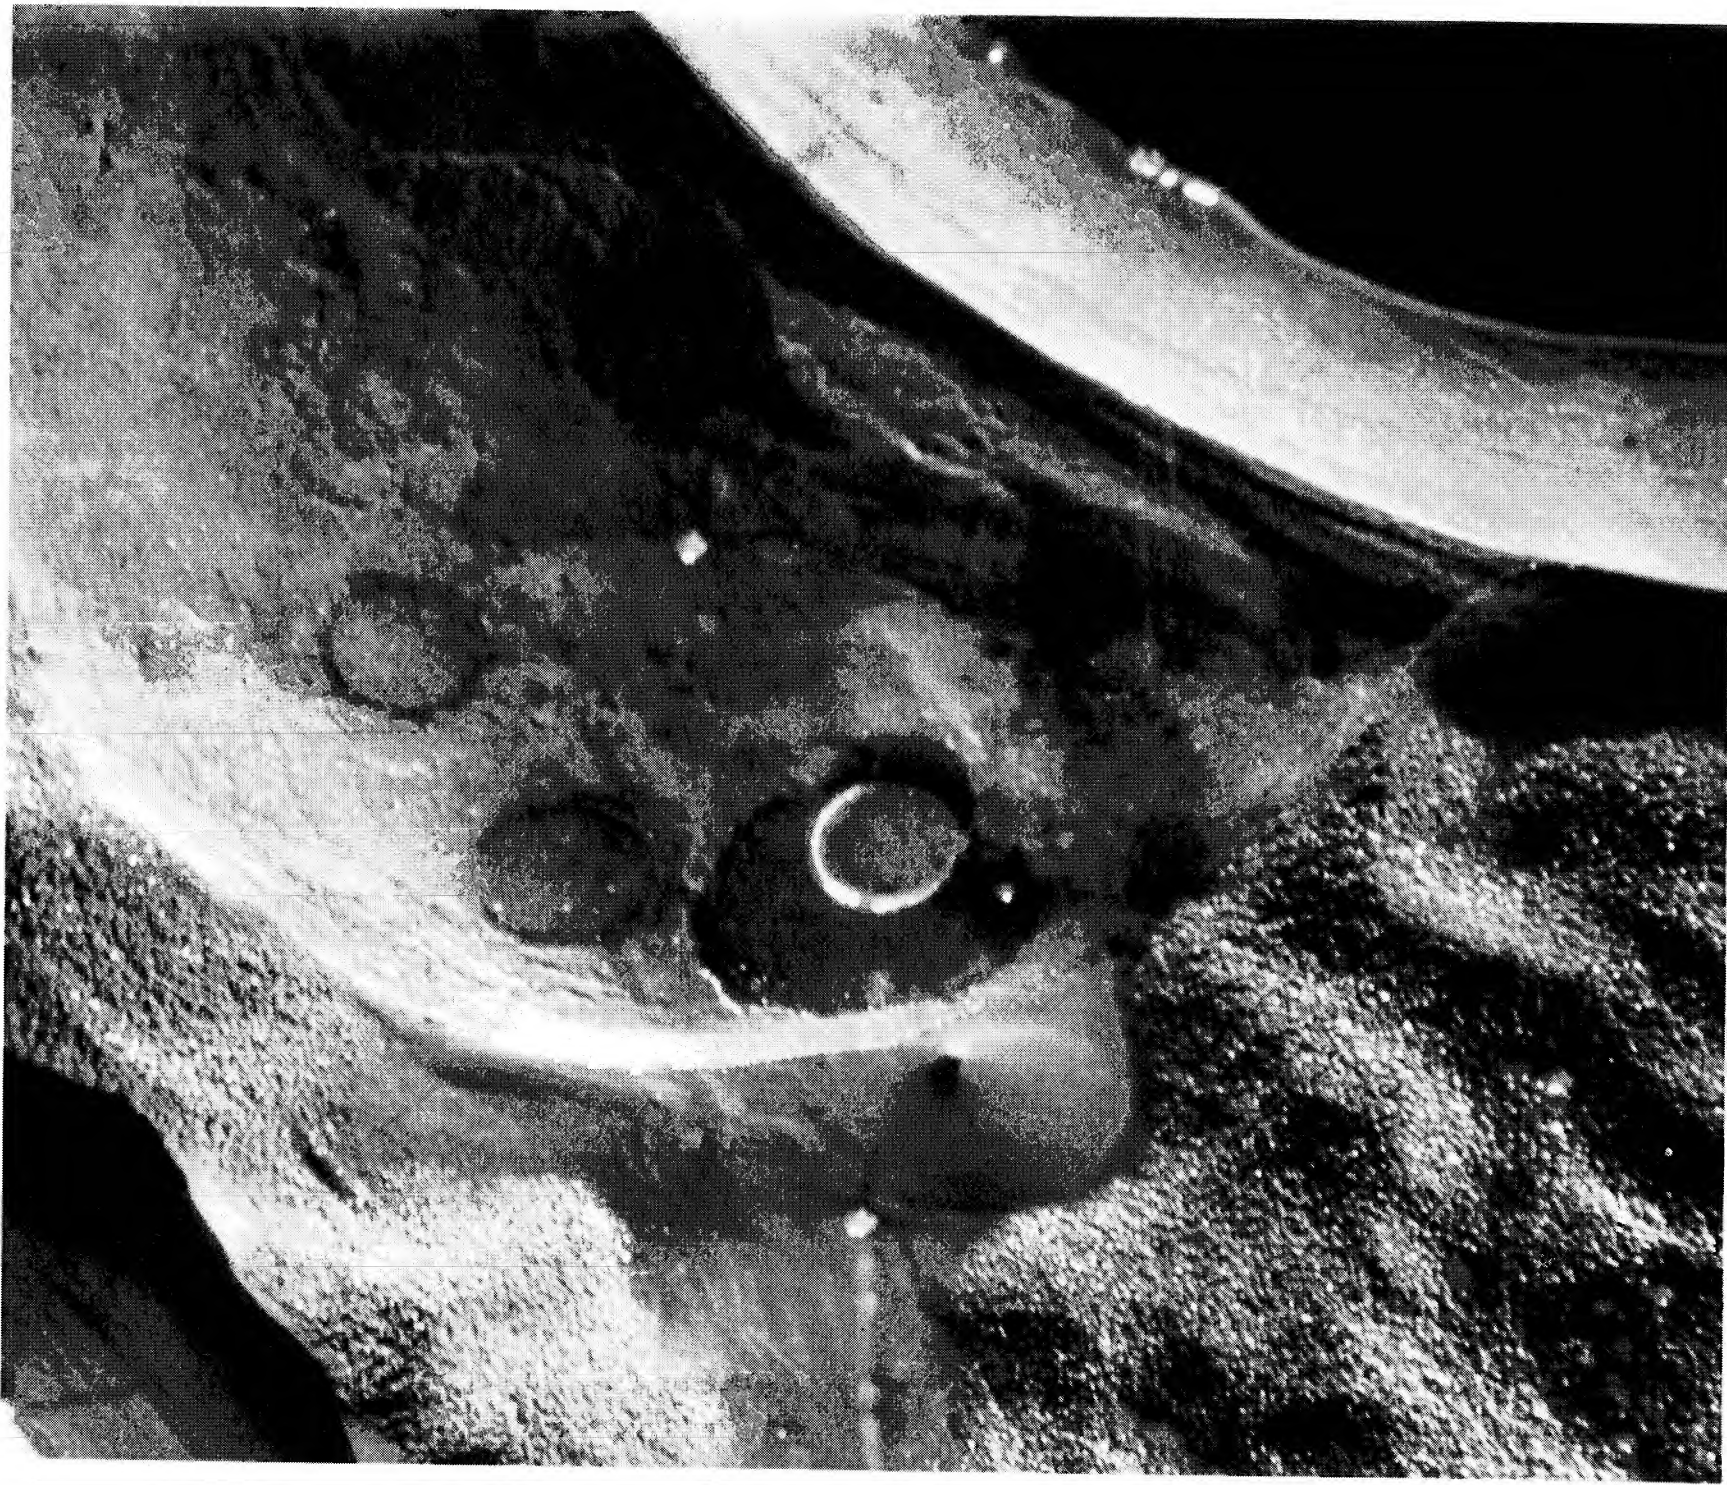
2 inches in diameter was protruding 3/8 inch. PR TS-0063 was taken and dispositioned with MRB approval to fly-as-is. Hard ice was present in the LO2 feedline bellows and support brackets. Light accumulations of frost on the LO2 ET/Orbiter umbilical were typical. The LH2 ET/Orbiter umbilical exhibited greater than average ice/frost accumulation. There were no unusual vapors emanating from the umbilicals or any evidence of leakage. The GOX vent duct hydro diverters from Pad B were installed on Pad A prior to cryoload and prevented icicle formation. Twelve Ice/Frost console anomalies were documented and found acceptable for launch per the LCC and NSTS-08303. At launch, the ET ice condition was well within the data base for ice formation.

Previous 3-inch diameter repair on LH2 tank aft dome apex  
begins to protrude due to cryopumping
